# **Analyst 1.7.2 Software Components for ExionLC 2.0 System**

Release Notes

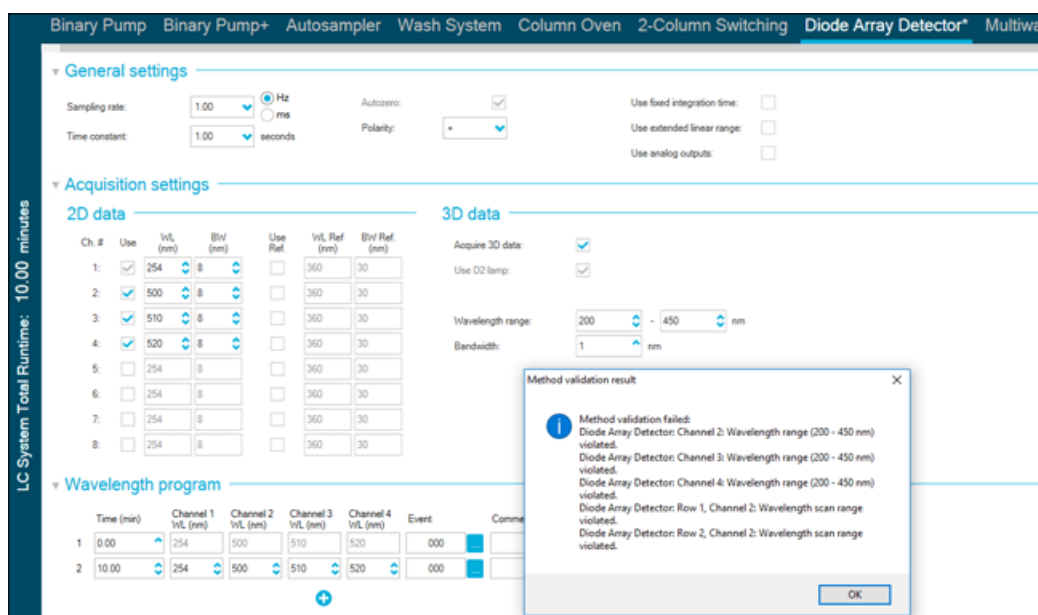
**Figure 2-1 Error Message when an Invalid ExionLC 2.0 DAD Method is Saved**

- When creating an LC method for a system with a DAD, make sure that the wavelength defined for each channel and each row in the Wavelength program for the 2D data mode is within the Wavelength range defined for the 3D data mode, even if the 3D data mode is not selected. The following figure shows the error message that is shown when an invalid method is saved. The Row <#> refers to the row in the Wavelength program.
