Analyst[®] 1.7.2 Software

Release Notes

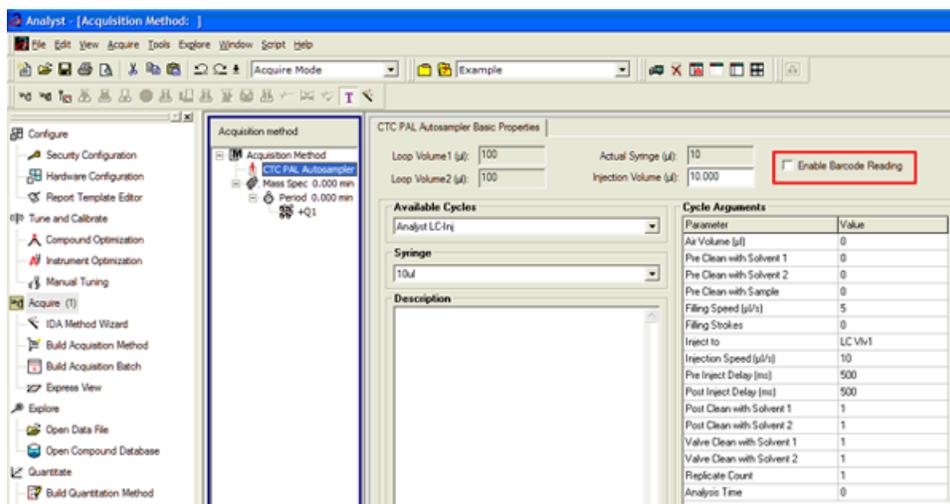
The CTC PAL Autosampler Method Editor now contains an **Enable Barcode Reading** check box. Selecting this check box (flag **ON**) activates the barcode reading and storing feature. Clearing this check box disables barcode reading.

Figure 4-1 Enable Barcode Reading check box

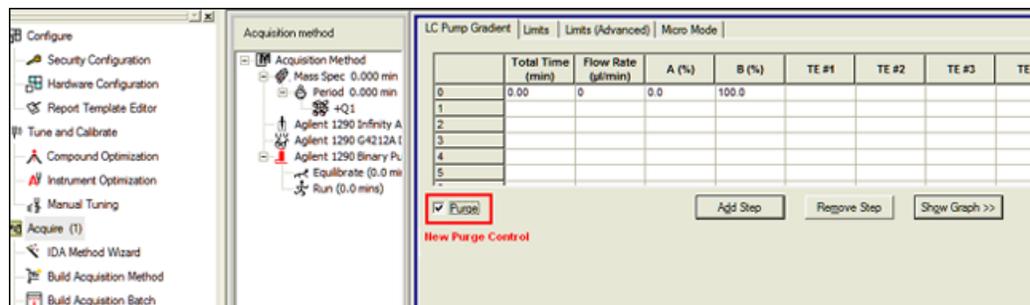
The Analyst® Software supports this functionality in both the Acquisition Method Editor and Manual Tuning through the **Purge** option.

Figure 4-2 Purge Option in the Acquisition Method Editor

When the **Purge** option is activated, the Agilent 1290 Binary Pump opens the purge valve, allowing system purging.

To create a purging method, use only the **Total Time**, **Flow Rate**, and **A/B(%)** fields. Values entered in the Limits, Limits (Advanced), and Micro Mode tabs are ignored.

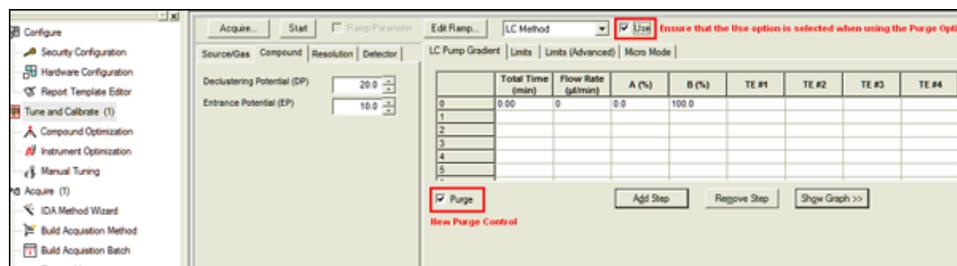
Figure 4-3 Purge Option in Manual Tuning

Use Manual Tuning to purge or prime the system or create an acquisition method to be used exclusively for purging. This method can be submitted via the Acquisition Batch Editor in the same manner as acquisition methods. In this scenario, the mass spectrometer acquires data to the specified wiff file.

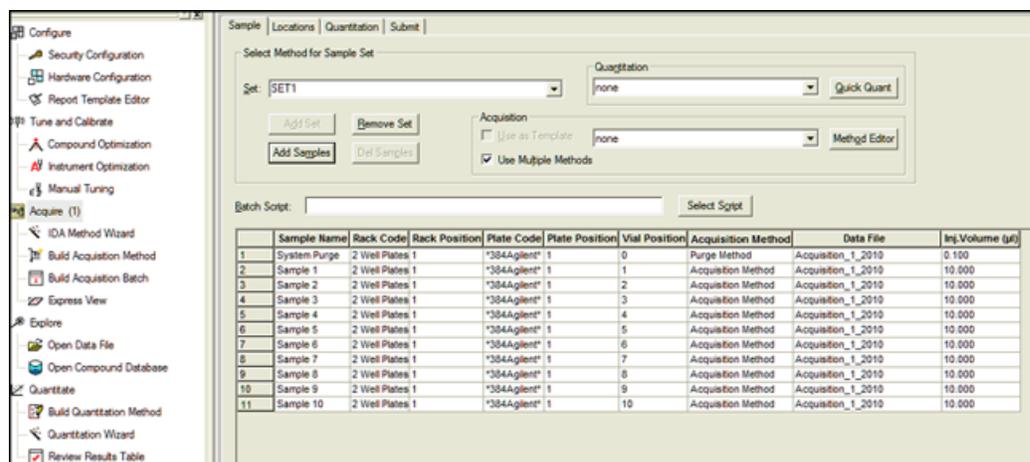
Figure 4-4 Example Acquisition Batch with a Purge Method Before Acquisition
