Analyst 1.7.3 Software

Release Notes

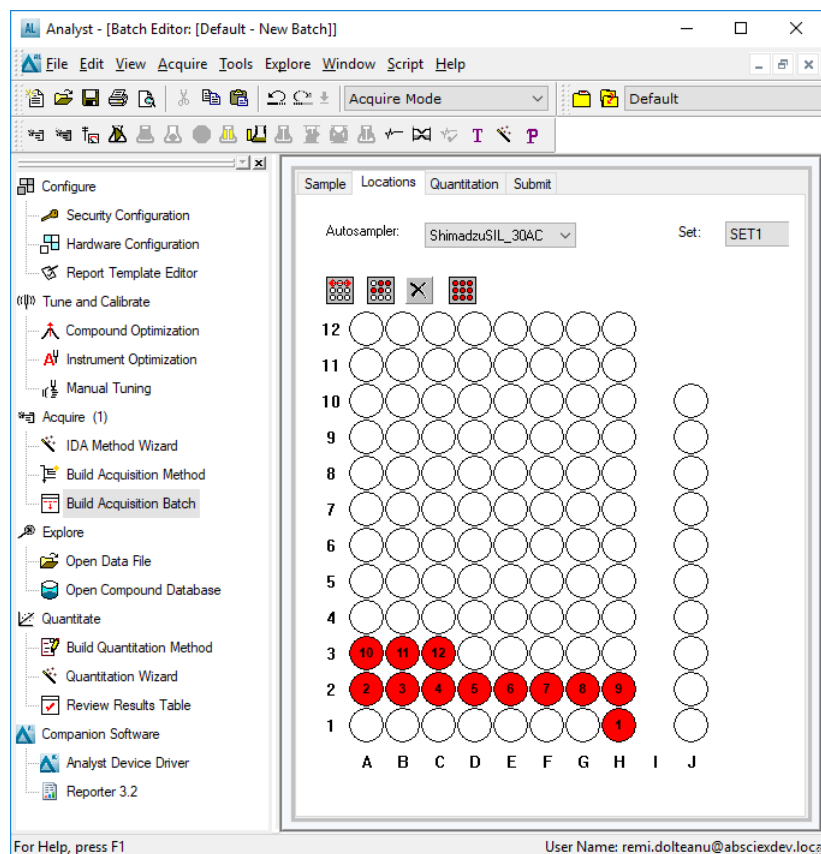
Figure 2-1 Batch Editor: Locations Tab

The 96 deep well plate layout with alphanumeric numbering starting from the bottom left of the plate, horizontally, is supported. Refer to the figure: [Figure 2-1](#). The following are applicable when this new plate is selected for the Shimadzu SIL-30ACMP or Shimadzu SIL-30AC autosampler:

Note: This support was first added in the **Analyst 1.7.2 Patch for Shimadzu LC30 Plate Layout.** (AN-1571)

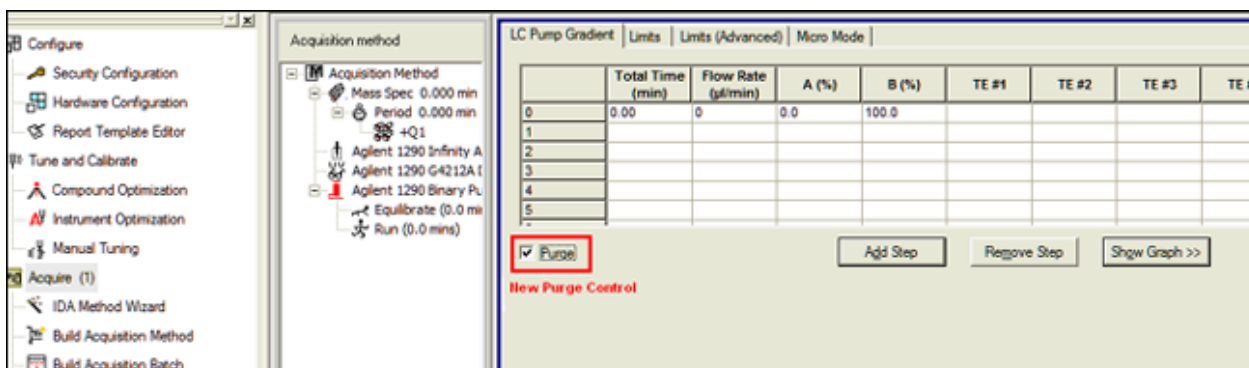
Figure 4-2 Purge Option in the Acquisition Method Editor

The Analyst software supports this functionality in both the Acquisition Method Editor and Manual Tuning through the **Purge** option.

When the **Purge** option is activated, the Agilent 1290 Binary Pump opens the purge valve, allowing system purging.

To create a purging method, use only the **Total Time**, **Flow Rate**, and **A/B(%)** fields. Values entered in the Limits, Limits (Advanced), and Micro Mode tabs are ignored.
